# Environmental and Social Monitoring Report

Semestral Report (July–December 2024)  
March 2025

## Vanuatu: Interisland Shipping Support Project

Prepared by the Ministry of Infrastructure and Public Utilities for the Vanuatu Government and for the Asian Development Bank (ADB).

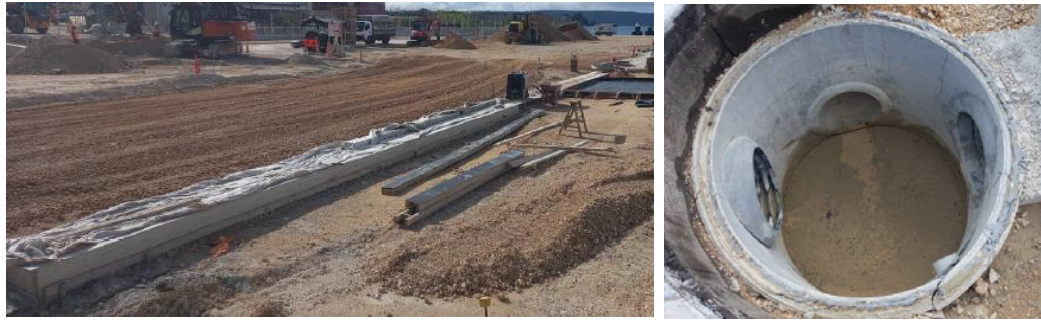
Figure 5 - Left picture shows last section of ACO drain is now complete. Right picture shows earthquake damaged manhole.

- The last section of stormwater drain has been completed. Some of the stormwater manhole risers were damaged by the December 17<sup>th</sup> earthquake. Repairs to these manholes have commenced.

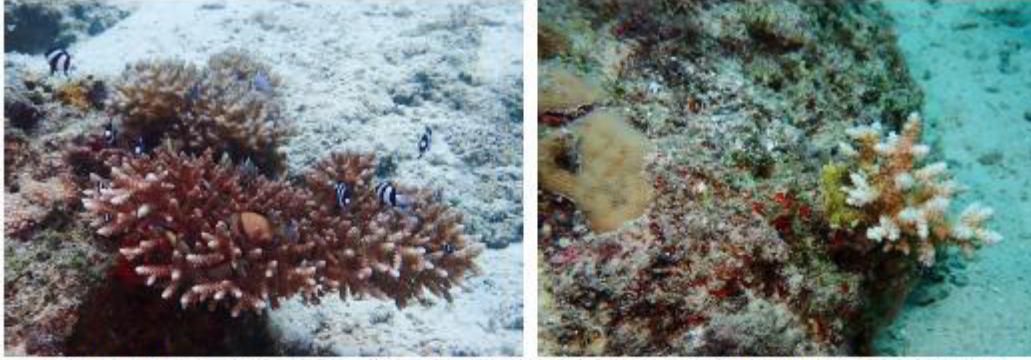
Figure 5: Half of the 15 the corals that survived to 36 months post-translocation have good live coral coverage.

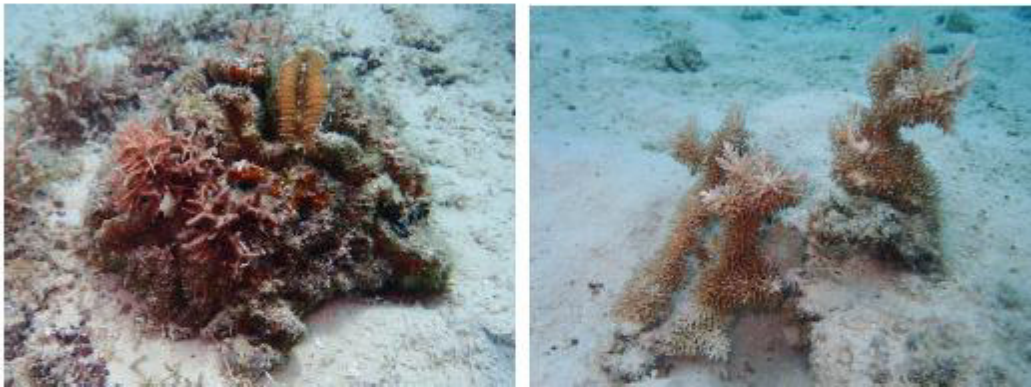
About half the surviving corals (7 out of 15) have lost coral cover in the last 12 months. The percentage coral cover has dropped to 75%. In every other monitoring period, it has been over 85%. Also, the number of coral colonies growing was not as high as previous monitoring events with only 27% of the corals having increased in size compared to 38% a year ago and 57% in 2022. 40% coral colonies were stable in size and five of the 15 coral colonies (33%) were recorded as having lost size compared to one a year before. The reduction on growth and coral cover may be a reflexion of the corals being less resilient after being damaged in 2023 and the continued poor water quality. No crown-of-thorns-starfish (COTS) nor the scars they typically leave on predated corals were encountered during the monitoring event.

Figure 6: Some corals have lost coral coverage such as this lobophyllia (left) and some have suffered physical damage and lost size like this acropora (right), although this one has retained good coral cover on the remaining branches.

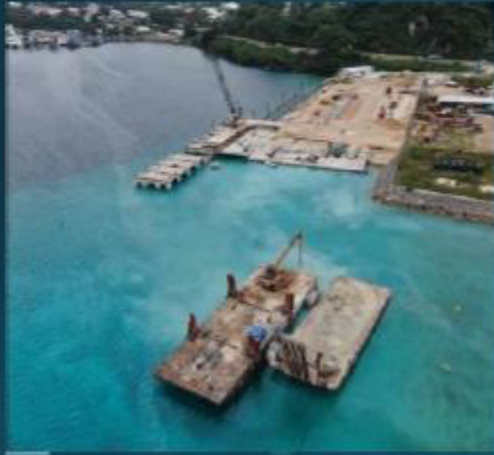
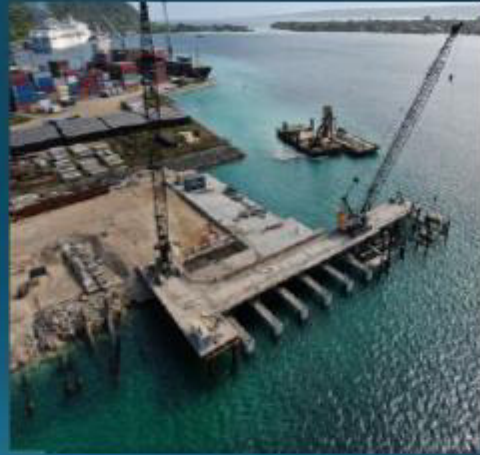
Why no usage of silt curtains??

1. Dredging operations will be carefully monitored by the contractor to ensure there is minimum impact to the water quality within the nearby coastal areas. Dredging operations is almost 60% complete.
2. Drone footage to be taken and shared to relevant authorities to ensure there is minimum impact and for record purposes.

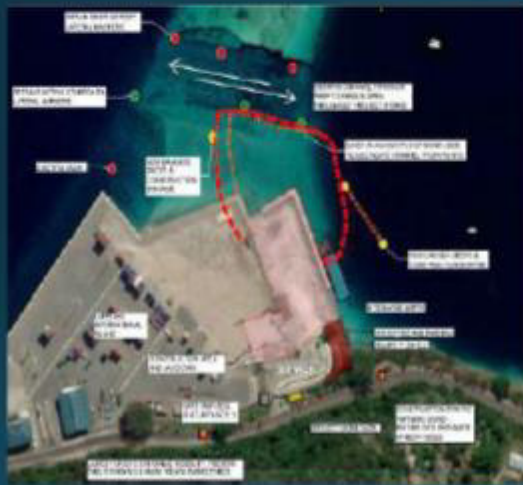
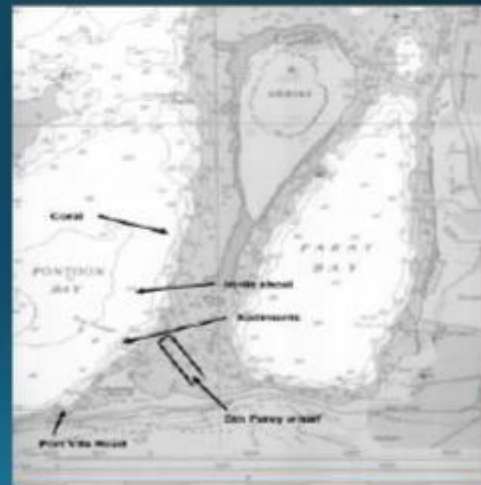
Turbidity flow coming from the South Eastern side of the Paray Bay flowing west towards the Project site. Dredging operation was on hold on the date this photo was taken.
