# Environmental and Social Monitoring Report

Semestral Report (July–December 2024)  
March 2025

## Vanuatu: Interisland Shipping Support Project

Prepared by the Ministry of Infrastructure and Public Utilities for the Vanuatu Government and for the Asian Development Bank (ADB).

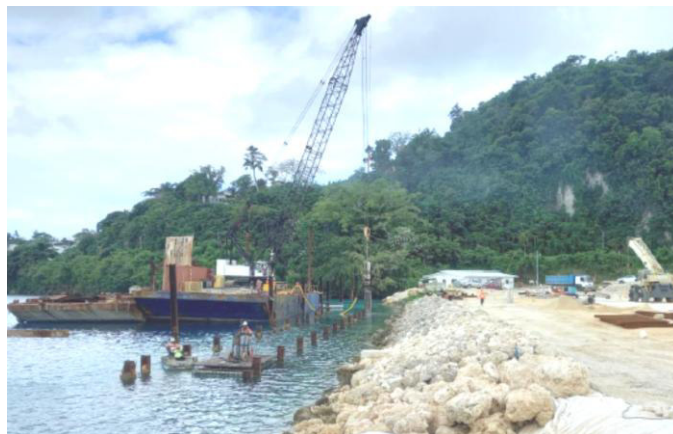
- The demolition of the old concrete wharf deck has been completed, and 86 old “H” piles have been removed or cut down, representing 72% of the 120 old “H” piles removed.

Figure 2 - Additional Ocean Logistics barge and crane in process of the old piles' extraction.

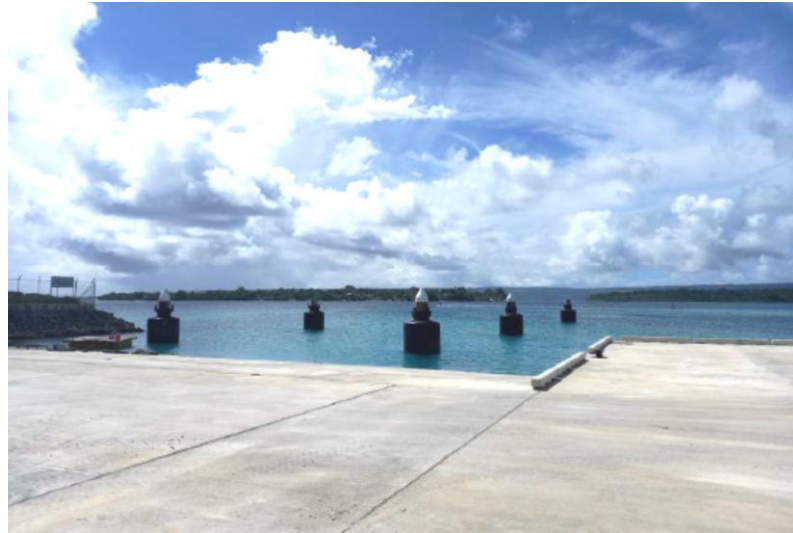
Figure 3 - Mooring piles and floating fenders have been completed.

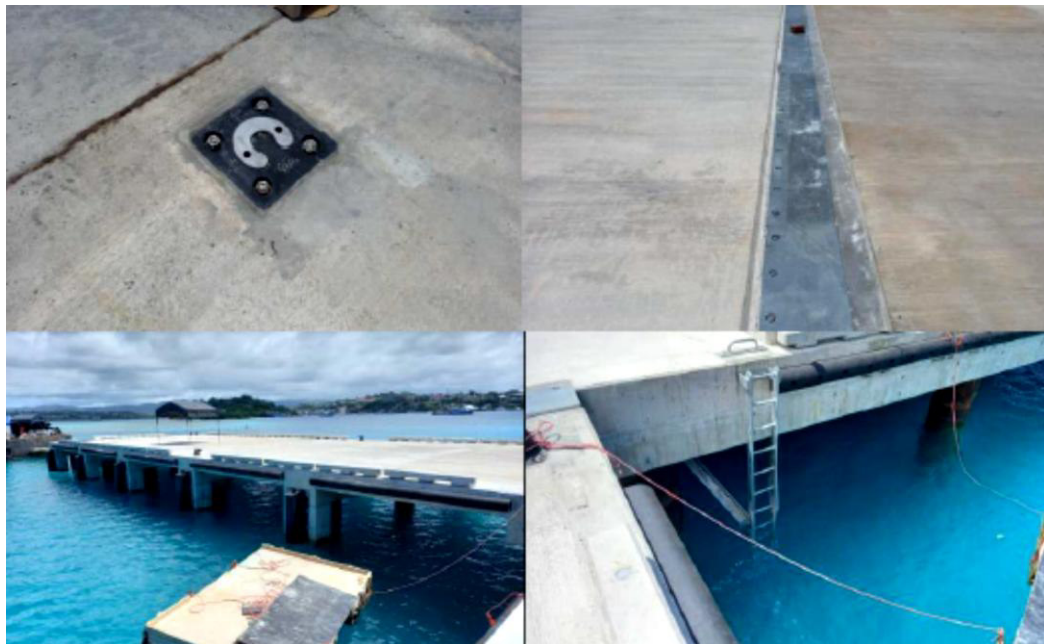
Figure 4: (Top left) Flush bollard on ramp. (Top Right) Seismic separation joint cover plate. (Bottom Left) Fenders, bollards and edge kerbs installed. (Bottom Right) Ladder.

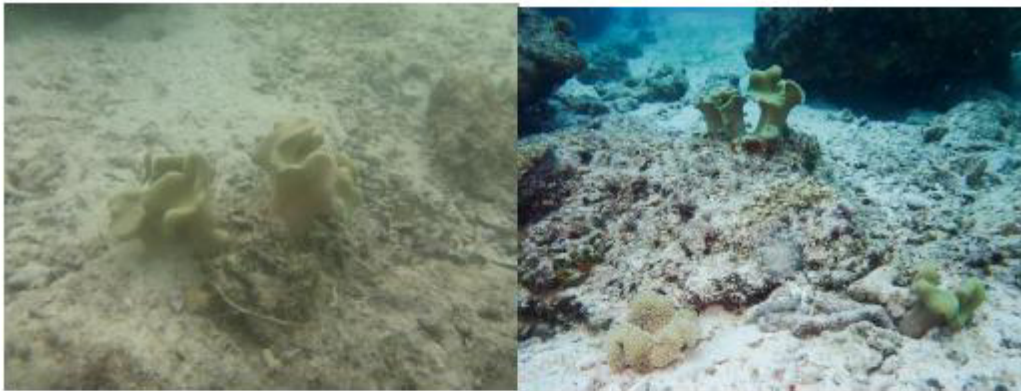
*Figure 7: The translocated leather coral colony at six months post translocation (left) and at 36 months post translocation (right). In the photo on the right new leather coral colonies can be seen in the foreground.*

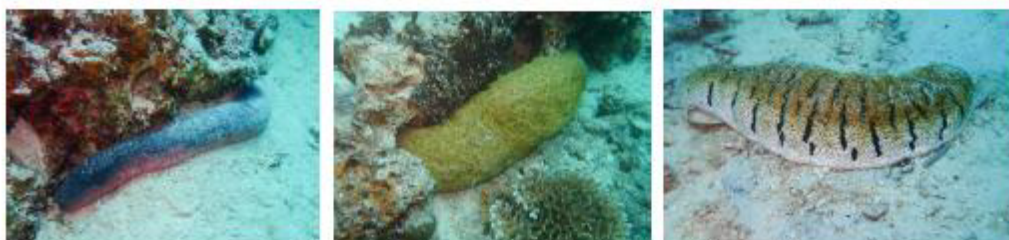
*Figure 8: Sea cucumbers seen during monitoring event including the vulnerable curryfish.*

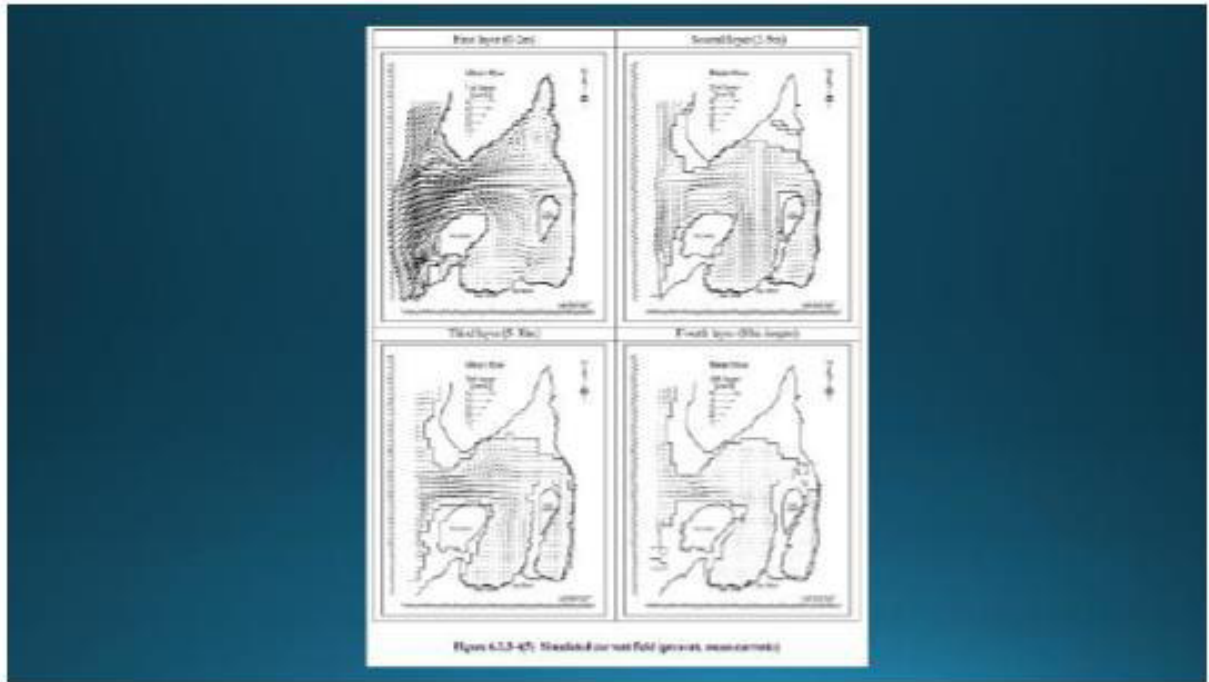
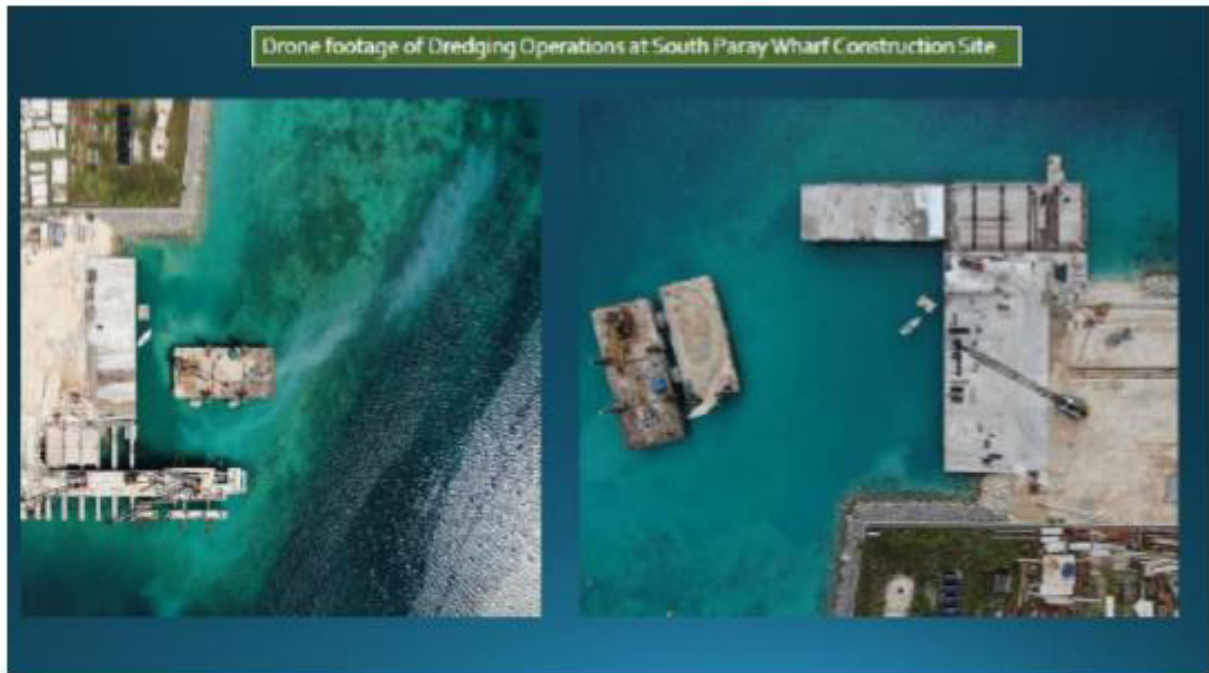
Drone footage of Dredging Operations at South Paray Wharf Construction Site

1. Dredging operations will be carefully monitored by the contractor to ensure there is minimum impact to the water quality within the nearby coastal areas. Dredging operations is almost 60% complete.
2. Drone footage to be taken and shared to relevant authorities to ensure there is minimum impact and for record purposes.

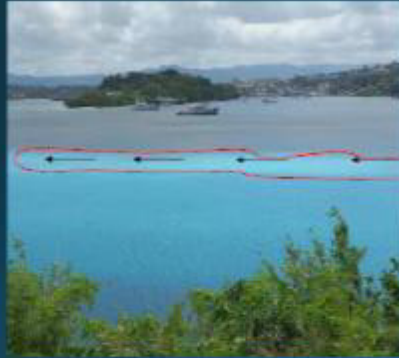
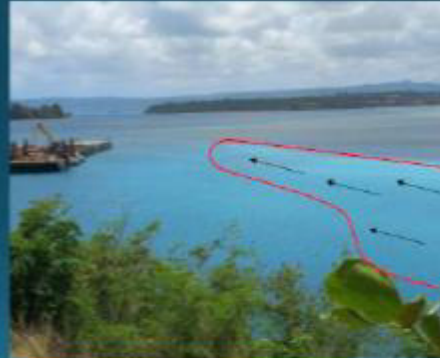
Turbidity flow coming from the South Eastern side of the Paray Bay flowing west towards the Project site. Dredging operation was on hold on the date this photo was taken.
